BROWNSVILLE PUBLIC UTILITIES BOARD
FLOCCULATION TRAIN STRUCTURAL IMPROVEMENTS
STRUCTURAL
MODIFICATION PLAN AND SECTION

JOB NO.
202284
DRAWING NO.
00S01
SHEET NO.
7 OF 14

FLOCCULATION TRAIN STRUCTURAL IMPROVEMENTS

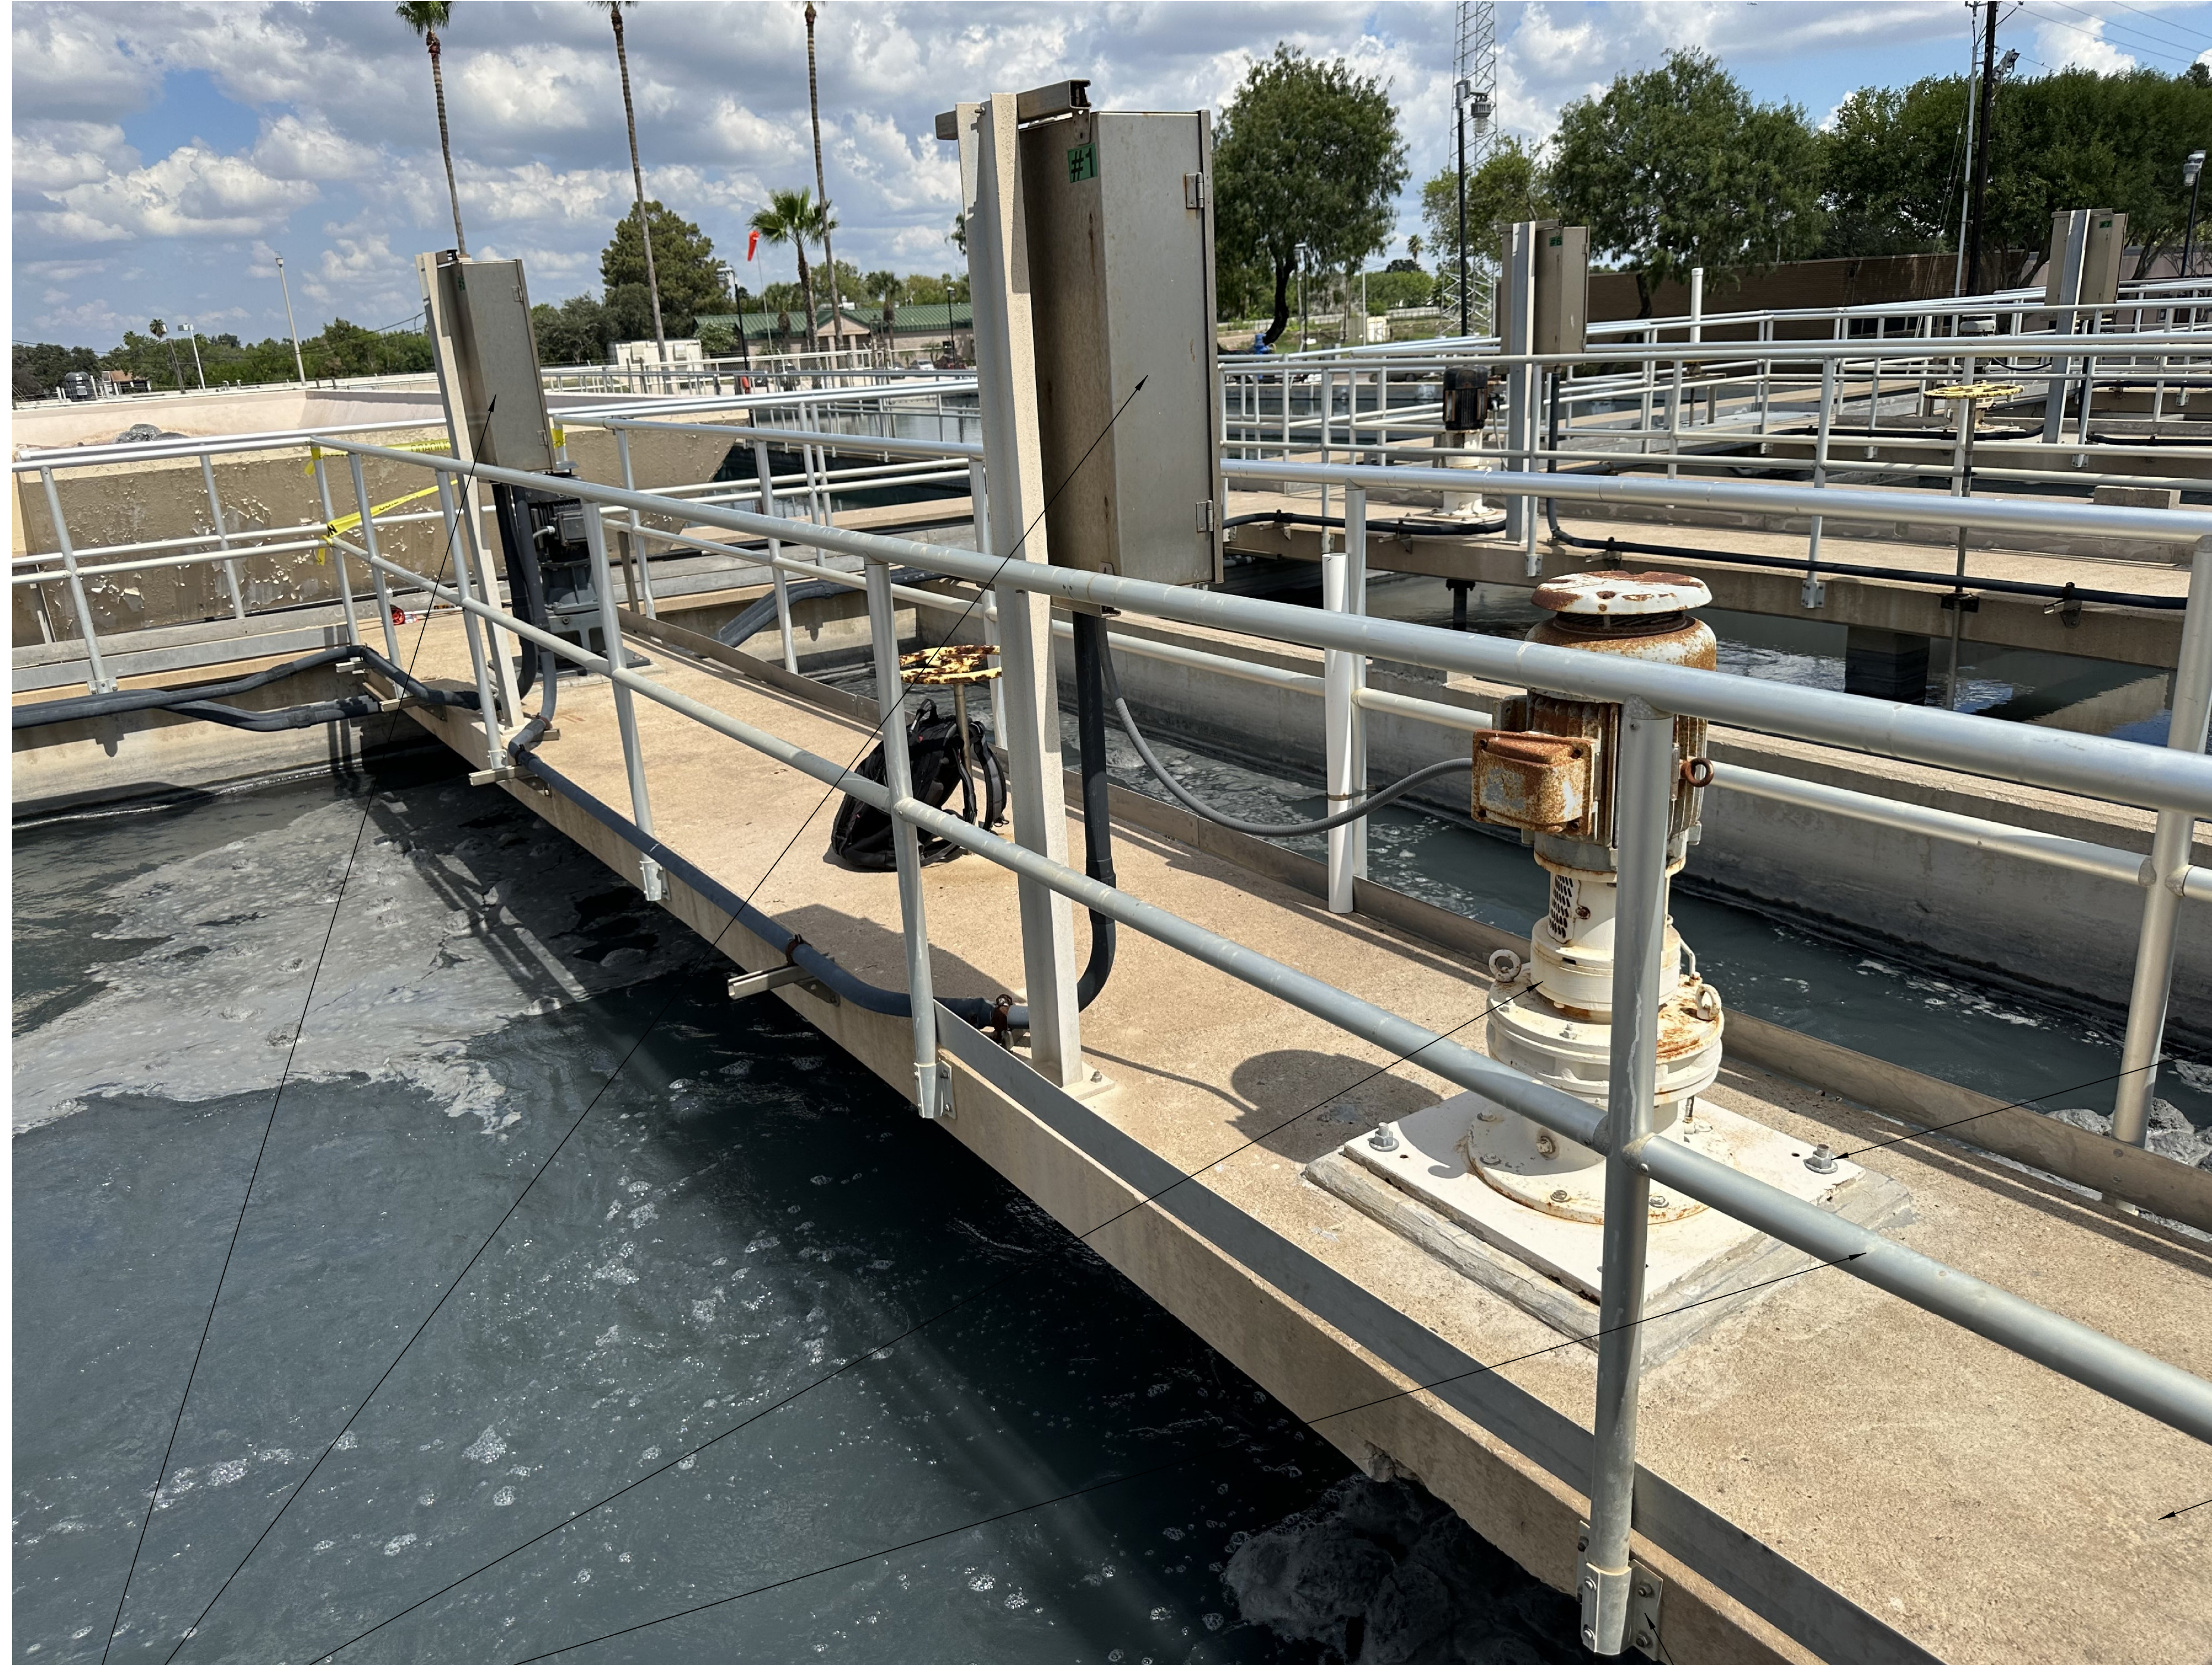
1 PHOTO
00S01
SCALE: NO SCALE
FILE:

REMOVE EXISTING FLOCCULATOR
AND MOTOR INSTRUMENTATION
PANELS, RAILING, CABLES AND MUD
VALVE UNIT AND STORE IT SAFELY
FOR REINSTALLATION
