U.S. ARMY ENGINEER RESEARCH AND DEVELOPMENT CENTER
LEWISVILLE AQUATIC ECOSYSTEM RESEARCH FACILITY

Resaca Boulevard Resaca Section 206 Aquatic Ecosystem Restoration Project:

Native Vegetation Establishment, Monitoring, Adaptive Management, and O&M

January 2021

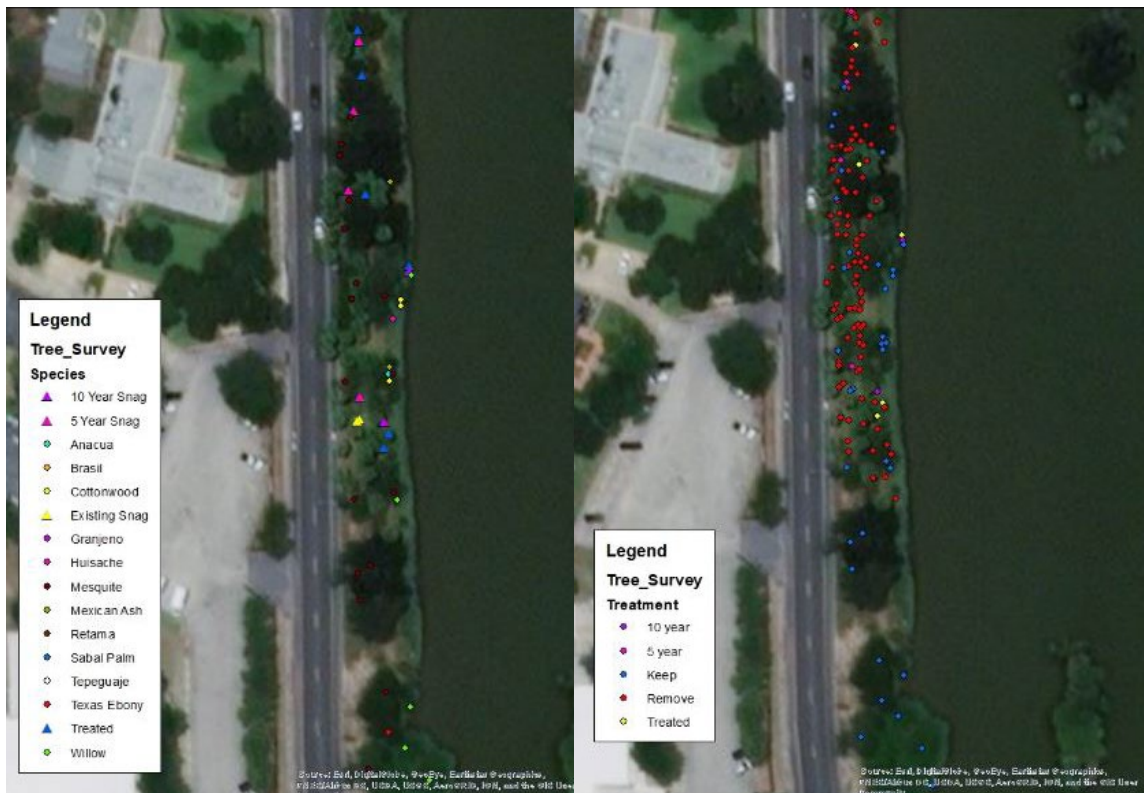
Figure 3. Paired maps that identify fate of trees to keep, remove, and treat (left) and the species of trees that remain (right).

ERDC-EL-LAERF also assisted in on-site biological monitoring of invasive species removal, native plant avoidance, improvements in installations, and other contractor activities throughout construction to ensure project success. Figure 3 illustrates an example of native plants to stay during invasive species removal phase (USACE RPEC).

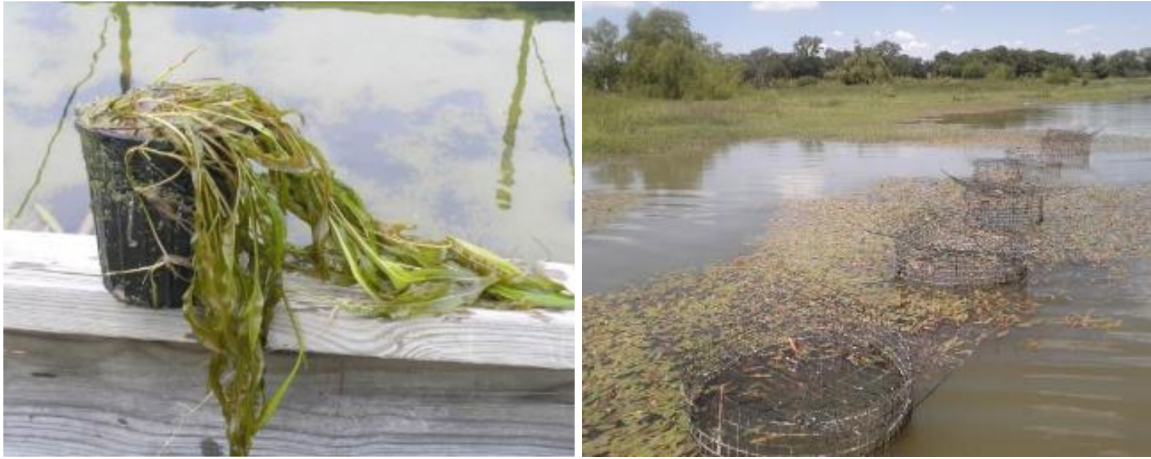
Figure 4. Field-ready containerized longleaf pondweed (*Potamogeton nodosus*) and other species were used to establish aquatic and emergent species at RBR.

Aquatic and emergent plants were mature transplants (Figure 4) with well-developed root balls, grown in appropriately sized 4-in (quart) to 6-in (gallon) plastic containers to facilitate recovery and growth after planting. Propagules (seeds, apical tips, and/or bareroot plants) were collected from appropriate ecoregions.

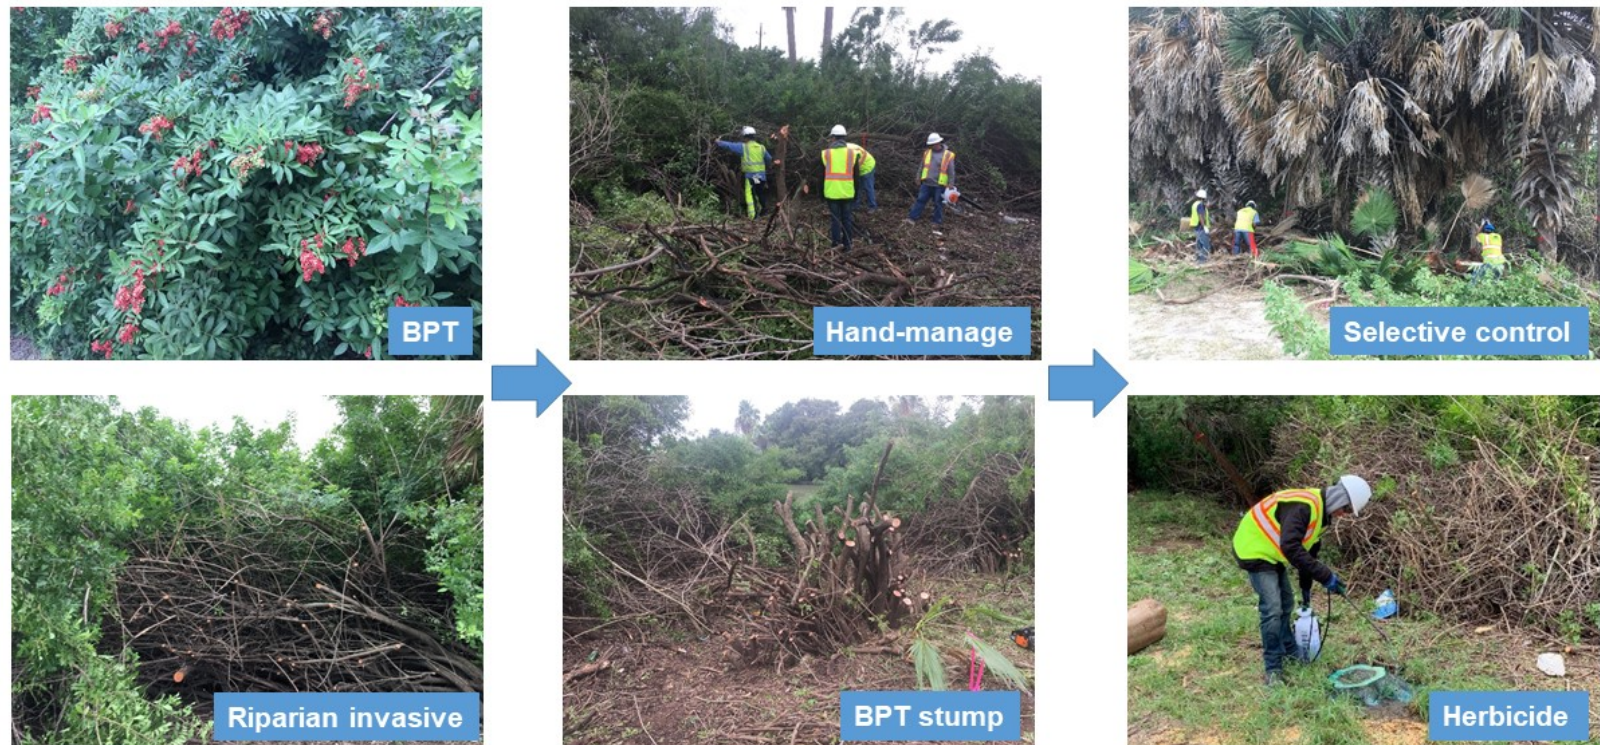
Resaca Boulevard Resaca – Brazilian peppertree management

Figure 6. Brazilian peppertree removal process at RBR project site.

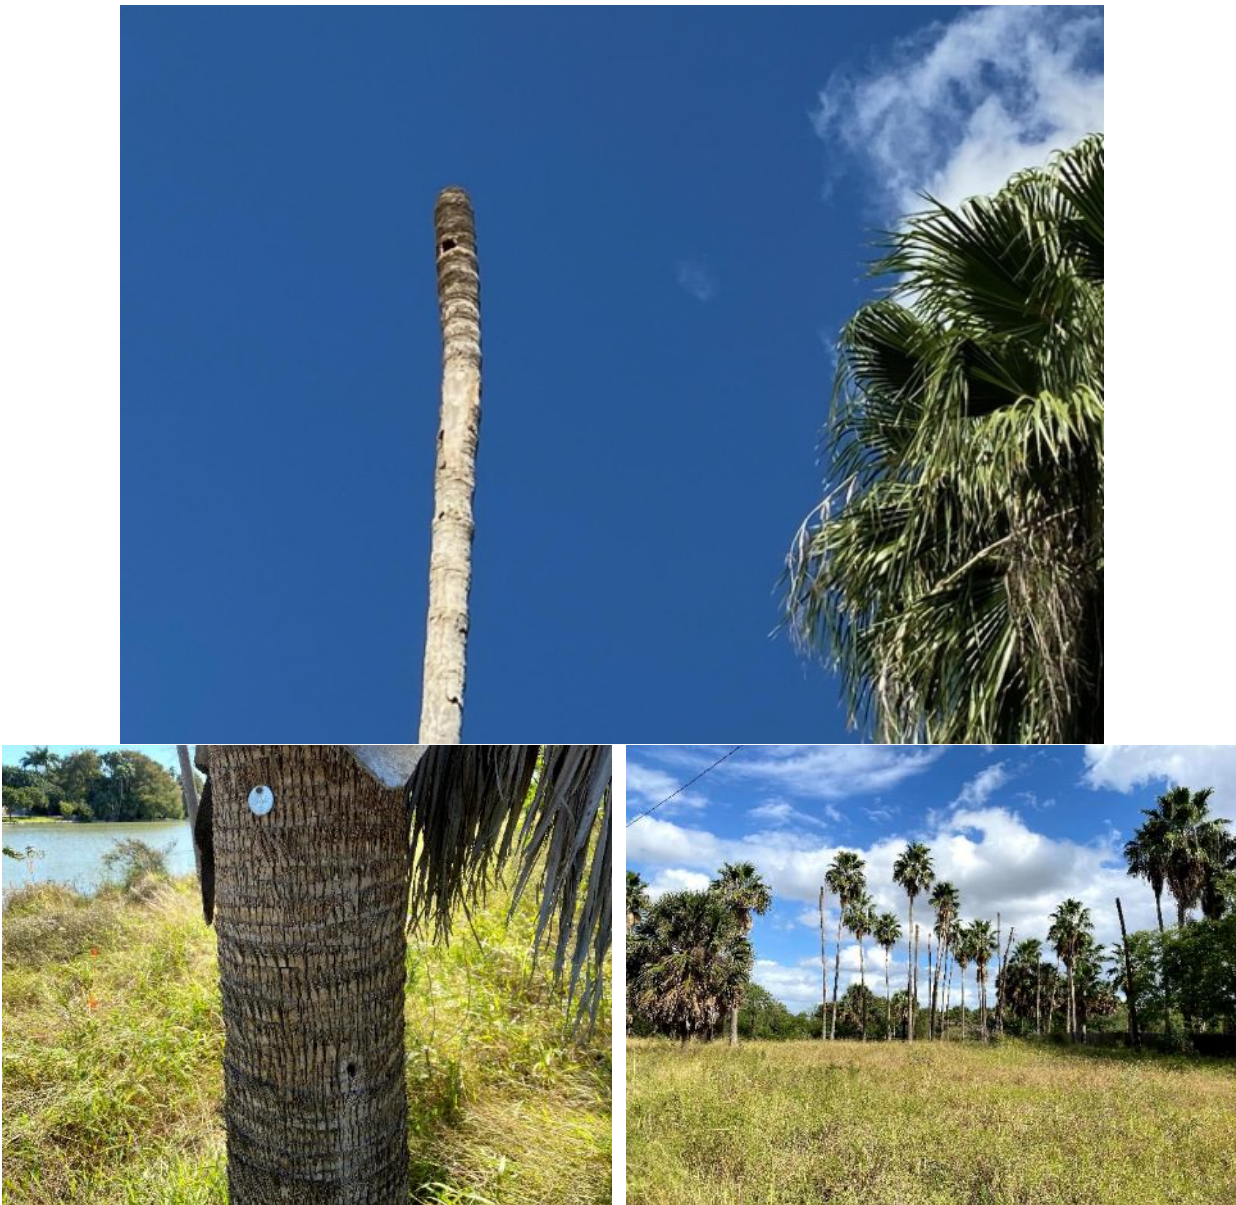
Figure 7. Non-native palm snags at RBR for the purposes of red-crowned parrot habitat.

Several non-native palms (Mexican fan palm or *Washingtonia robusta*) were treated with herbicide to create nesting habitat, primarily for the red-crowned parrot (Figure 7); 1/3 of non-native palms were snagged in construction, 1/3 scheduled to-be snagged in 5-yrs, and the remainder in 10 years. A snag here refers to a standing dead tree rooted into ground. Palms were converted to snags by treatment with herbicide using the following procedure: drill three 5/16 to 1/2-inch diameter holes in the palm tree spaced evenly around the trunk at chest height ensuring each hole reaches the center of the tree; fill with a 41 percent solution of glyphosate herbicide; let herbicide soak into the tree and repeat; after a few days, fill with herbicide one more time, and leave in place.

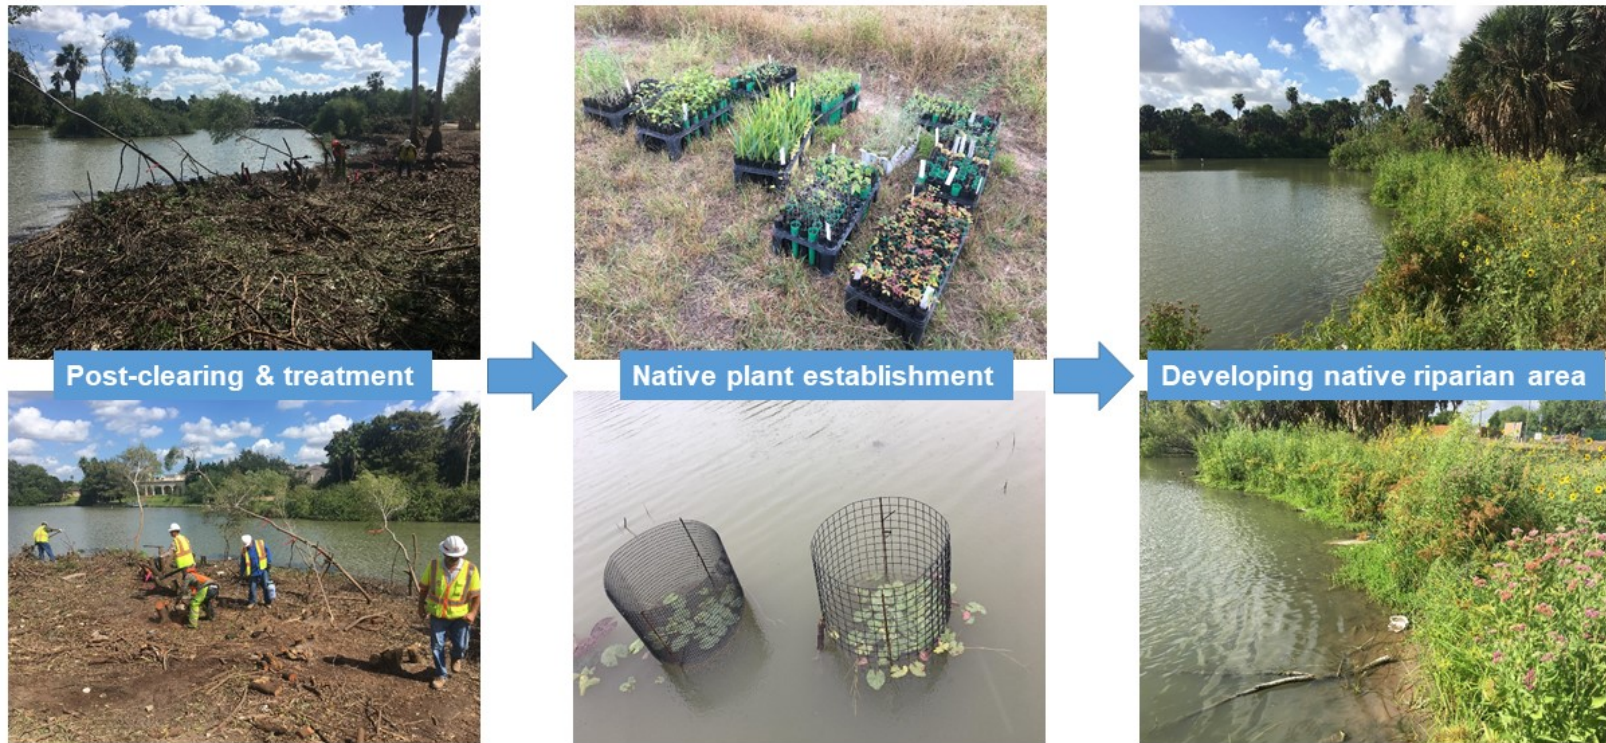
Resaca Boulevard Resaca – Native plant establishment

Figure 8. Native plant establishment process at RBR; top left - clearing project section and treatment of Brazilian peppertree and other invasive species; bottom left - contractors clearing project area; middle top - terrestrial native plants are planted following clearing and seeding; middle bottom - aquatic plants caged for herbivore protection during early establishment and; top & bottom right - developing native riparian area after re-sloping and planting.

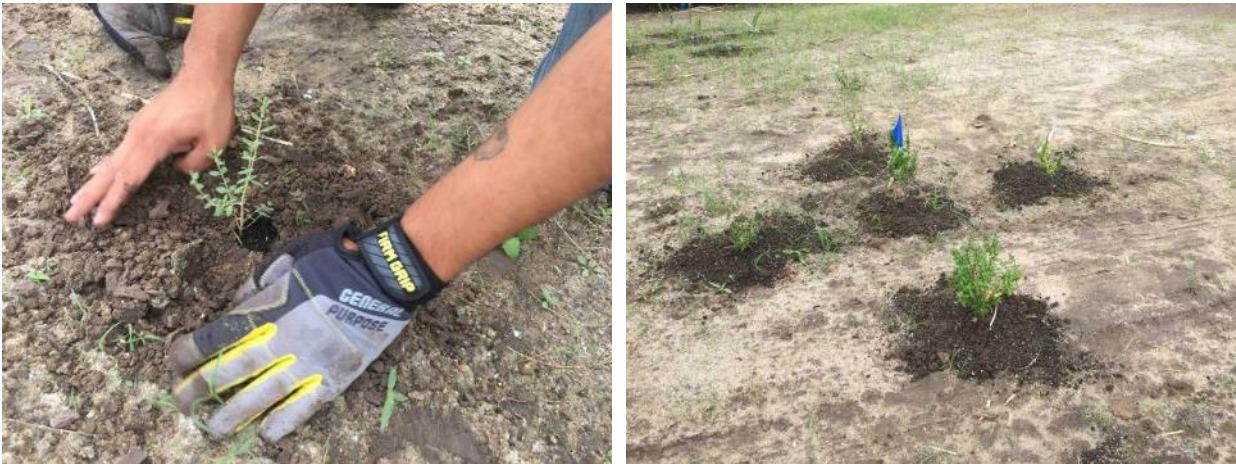
Figure 9. Woody and herbaceous vegetation planting in riparian areas at RBR in April 2019.

The first planting effort consisted of woody and herbaceous containerized plants (riparian or shoreline and upland) to promote the RBR ecosystem restoration goals of native plant establishment. Plantings occurred in two general areas, south and north sites from a species selected list (Table 4). Plants were placed in clusters leaving 7-10-ft in between to enable mowing over herbaceous cover when necessary. Holes were dug using small gas-powered augers and plantings were backfilled with on-site sediment. The majority of the plants were planted on the land-side of the existing silt fence, while 26 Montezuma cypress and 9 ash trees were planted +4-ft away from silt fence towards the water (lower elevation, saturated soils). On the south site, a total of 330 plants were planted including 5 Rio Grande palmettos and 10 Montezuma cypress. On the north site, 231 plants were transplanted, including three clusters of sabal palms (approximately 25 each) along with 16 Montezuma cypress plants. The north end also included a one 10-ft x 30-ft flag marked woody seeding location containing native plants (Rio Grande palmetto, sweet acacia, ebony, blackbrush acacia, cedar elm, crucillo, tenaza, hog plum, and anacua). Starting 15 April 2019 and on a monthly basis, ERDC-EL-LAERF assessed plant and vegetation site conditions. Figure 9 illustrates planting method results of first plantings efforts, April 2019,

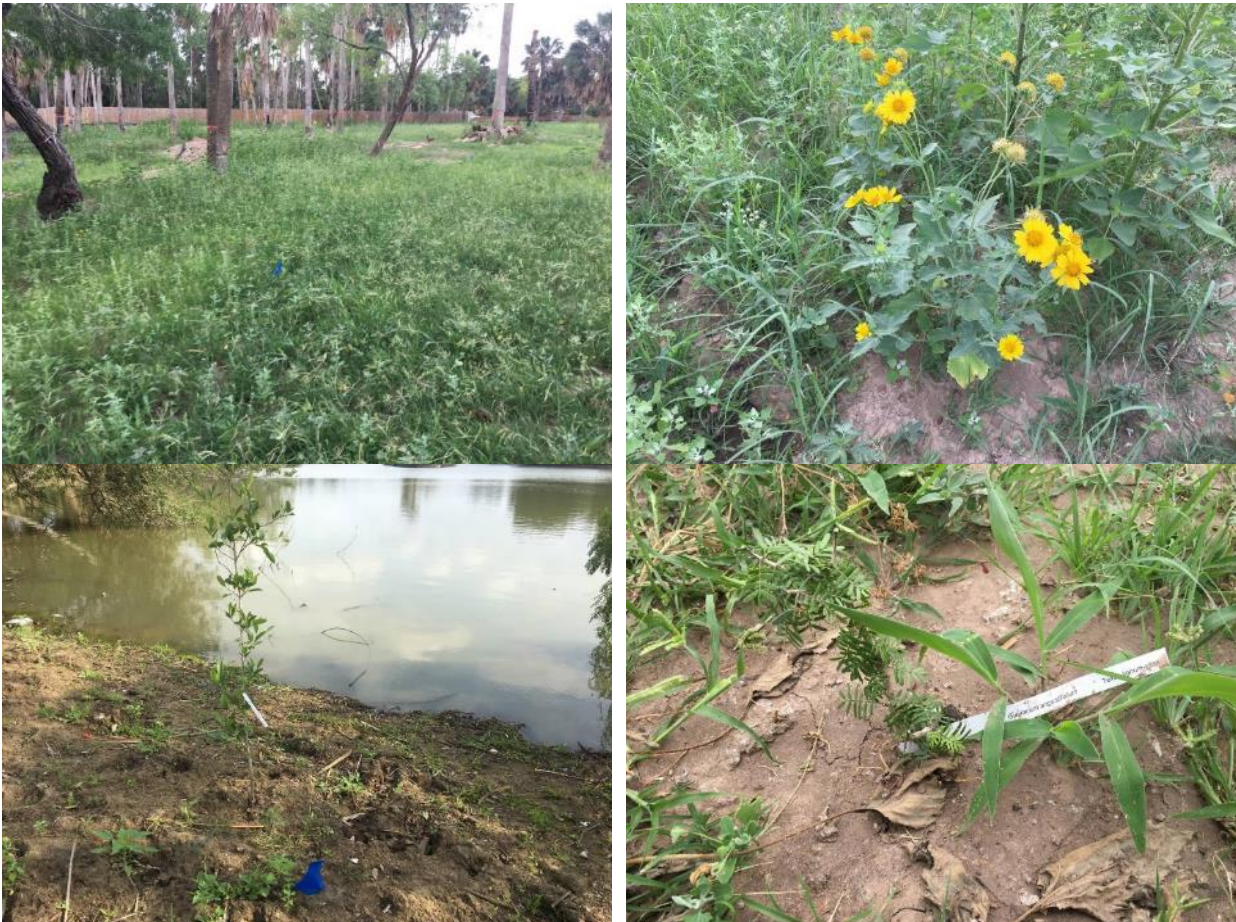
Figure 10. First site assessment (1 May 2019); top left - successful seeding; top-right - cowpen daisy; bottom left - woody species planted, Mexican Ash; bottom right - Texas ligum-vitae.

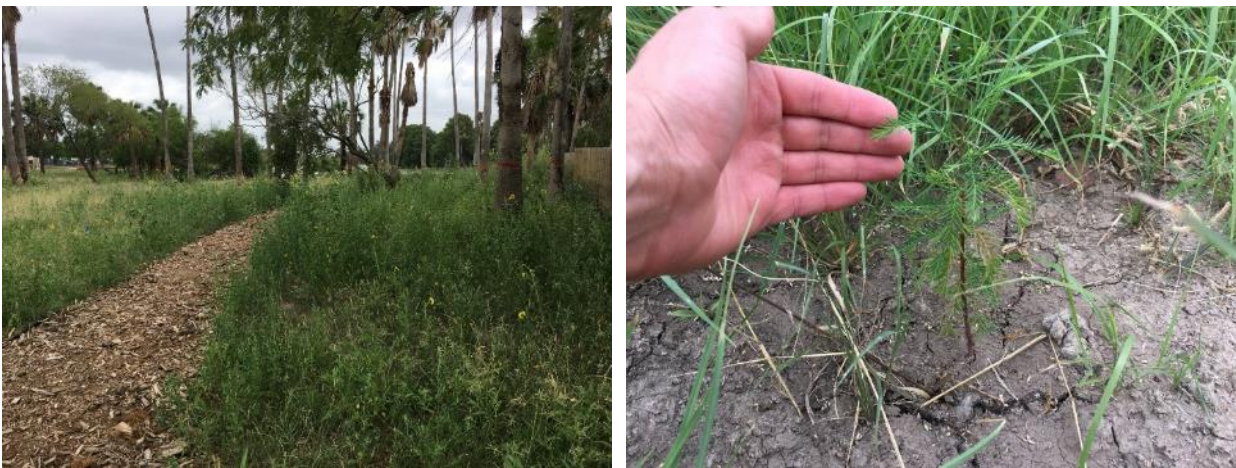
Figure 11. Left - showing growth of seeding, and; right – planted Montezuma cypress; 28 May 2019.

A second site assessment occurred 28 May 2019. Transplant survival was estimated at approximately 95% with minimal herbivory observed. Smaller transplants appeared more successful than larger transplants. Most previously seeded native herbaceous vegetation had gone to seed (Figure 11), whereas remaining aggressive annual sunflowers had just begun flowering. Therefore, the project-site first mow was scheduled for late June at an appropriate height to minimize damage to shorter, desirable species, reduce annual sunflower seed production, and promote native grass spread in the following growing season. Other native volunteer wildflowers were observed in the seeded area, including Mexican hat and plains coreopsis. A volunteer wetland vegetation fringe dominated by native volunteers was observed to be developing between the silt fence and shoreline (Figure 12) and was designated as a no-mow area.

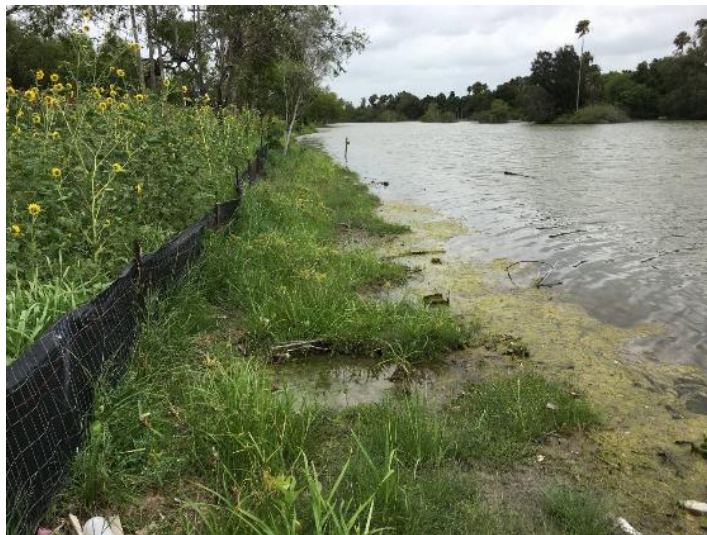
Figure 12. Wetland fringe developing within silt fence in no-mow designated area.

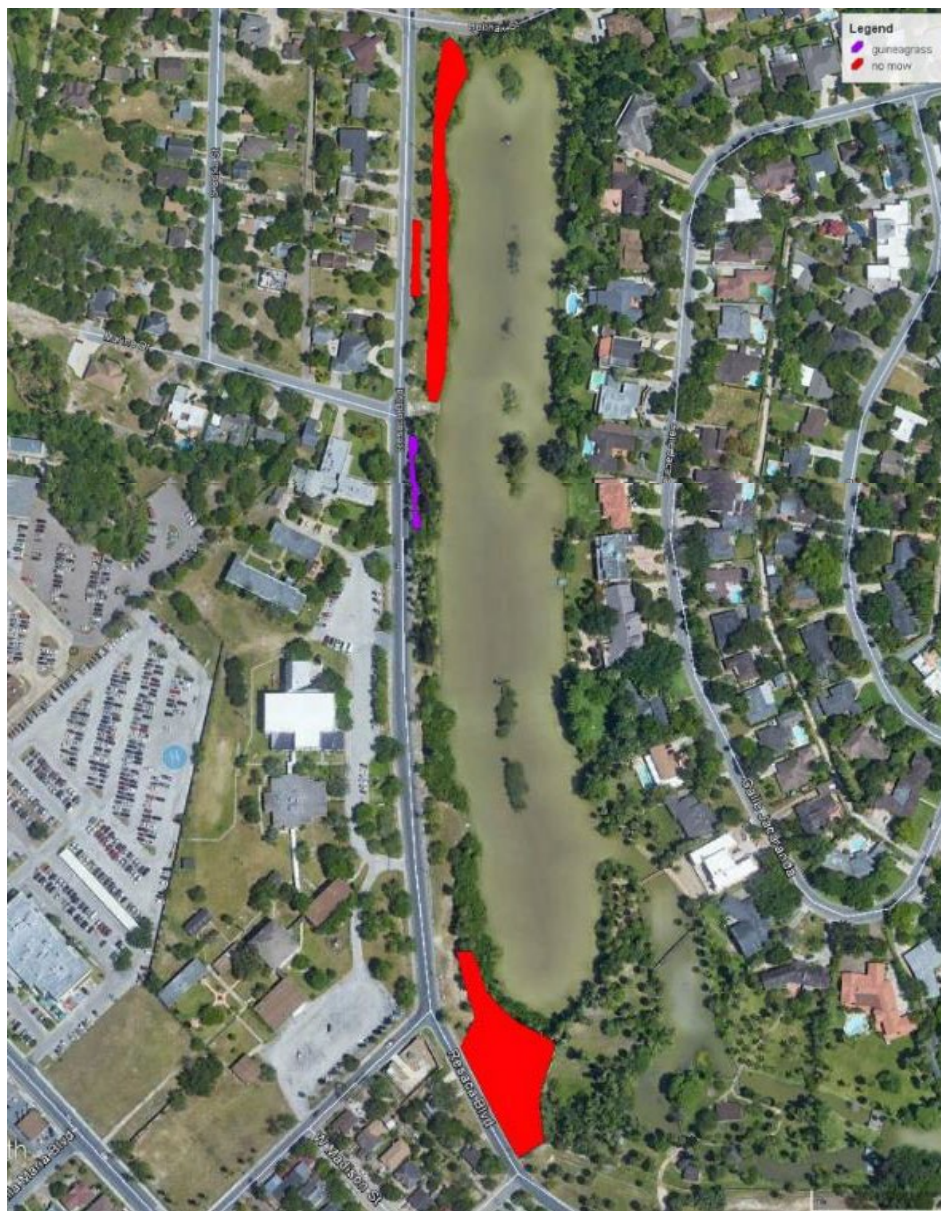
Figure 13. Map showing area with no-mow locations and the invasive guineagrass.

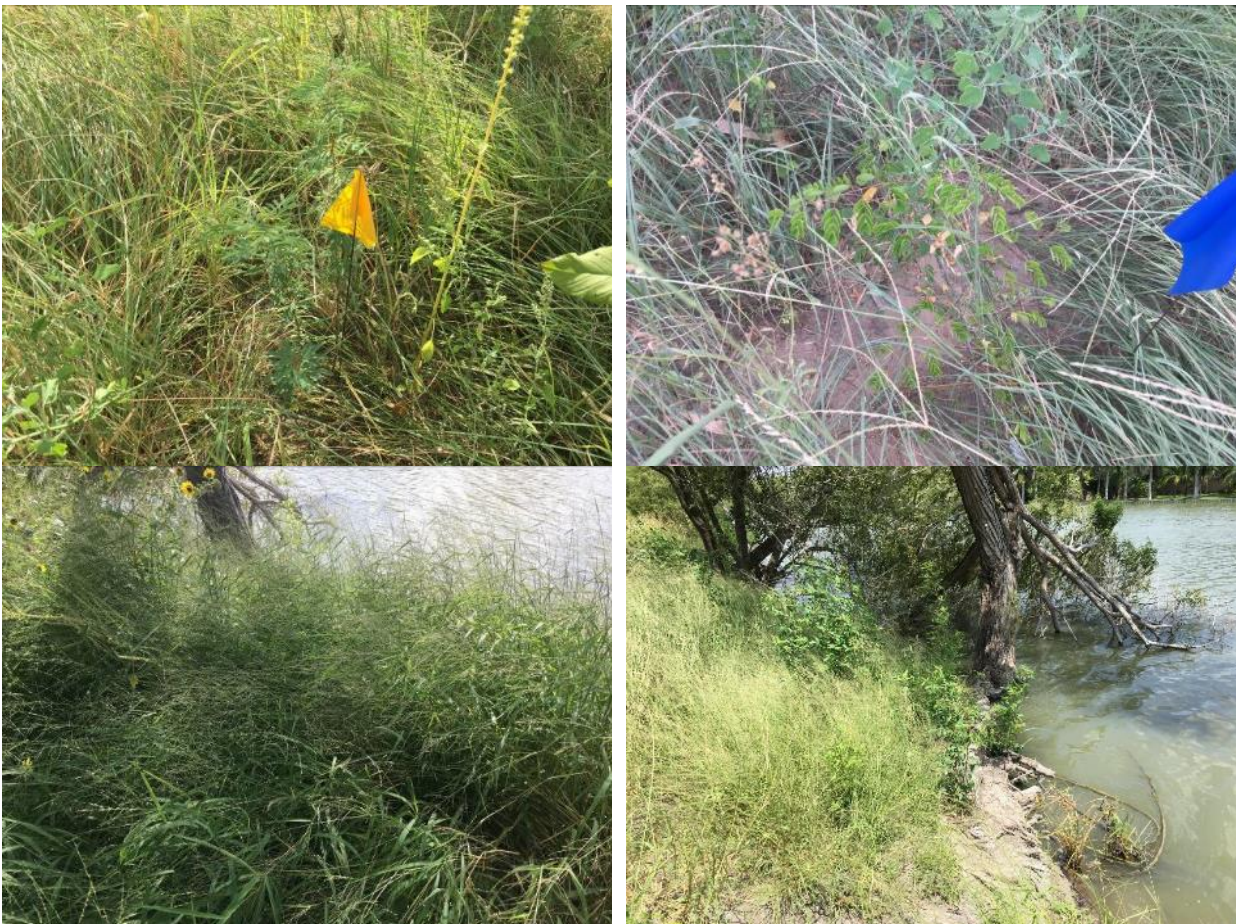
Figure 14. July 2019; top left - acacia transplant; top right - Mexican holdback transplant; bottom left - invasive guineagrass, and; bottom right - invasive Brazilian peppertree regrowth.

The next assessment occurred on 17 July 2019, in which woody vegetation transplant survival remained around 90% with minimal herbivory observed (Figure 14). As in the earlier assessment, smaller transplants continued to be more successful than larger transplants (lowest mortality observed in smaller, younger, and 1-year-old transplants). Other observations included measurable above-ground growth in certain species, such as Montezuma cypress, acacias, ebony, hackberries, and Mexican Poinciana. The post-seeded truck irrigation path exhibited poor establishment from seed in a few areas. Guineagrass had moderately expanded in no-mow areas to an estimated 15% coverage and occasional Brazilian peppertree and Chinese tallow seedlings occurred in small numbers and were scheduled for later treatment (Figure 14).

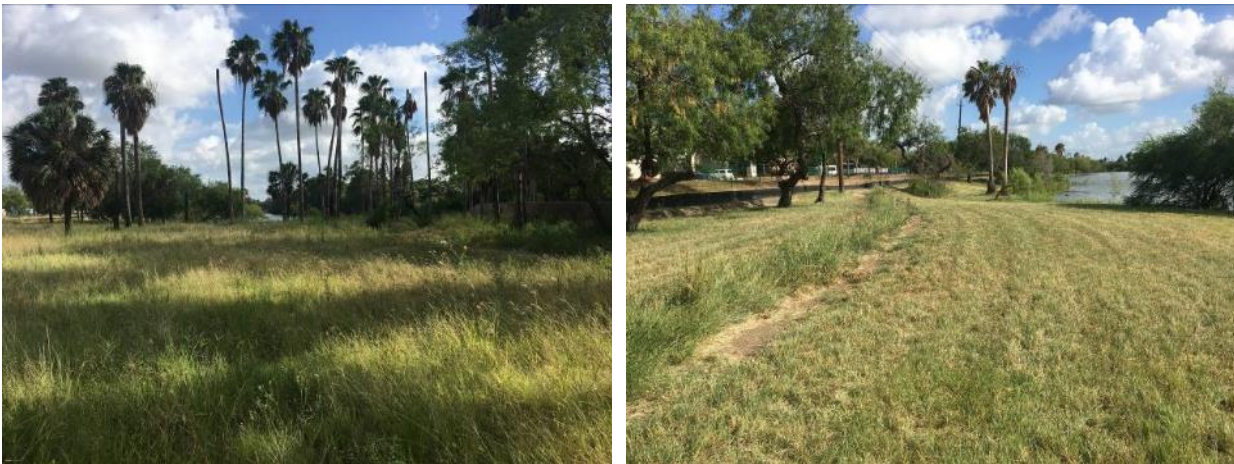
Figure 15. Left - mow, and; right - no-mow zones - 17 July 2019.

The first mow versus non-mow areas was assessed and appeared to be successful by the contractor (Figure 15). Thirteen species from the seeding efforts were observed (Table 5) and ground coverage was >80%. Some remaining annual sunflowers had gone to seed and occurred at their highest density in the north planting area. Annual plant senescence was expected to reduce the “eye-sore” issue raised by some residents. After going to seed, any contractor efforts to remove standing vegetation would be for general aesthetics and would not contribute to control in subsequent

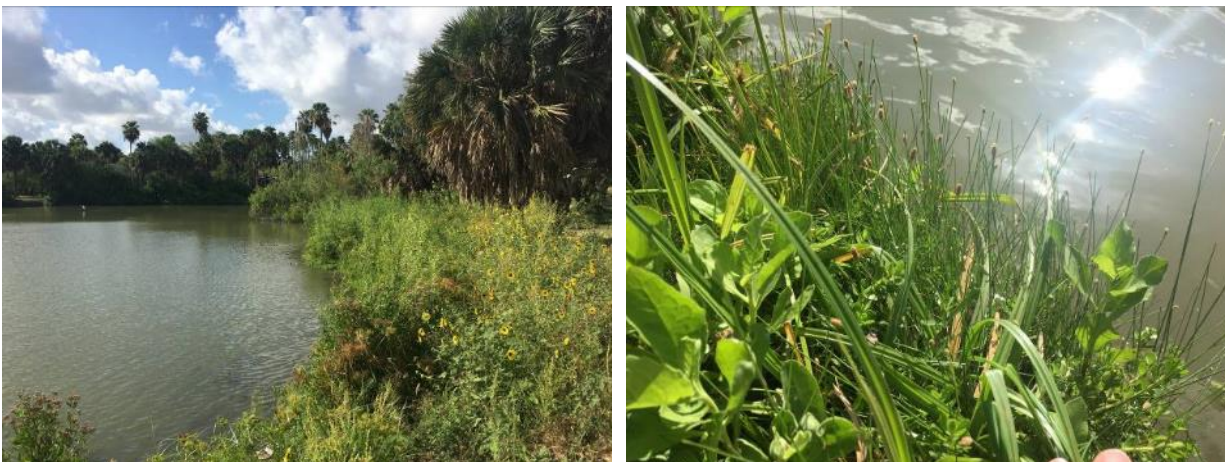
Figure 16. Wetland fringe developing with native plants; left - within silt fence in no-mow designated area; right – waterhyssop and spikerushes.

Wetland fringe vegetation continued to naturally develop following construction (Figure 16); dominated by native emergent volunteer species. To increase diversity of the wetland fringe and ensure establishment of floating-leaved and submerged vegetation,

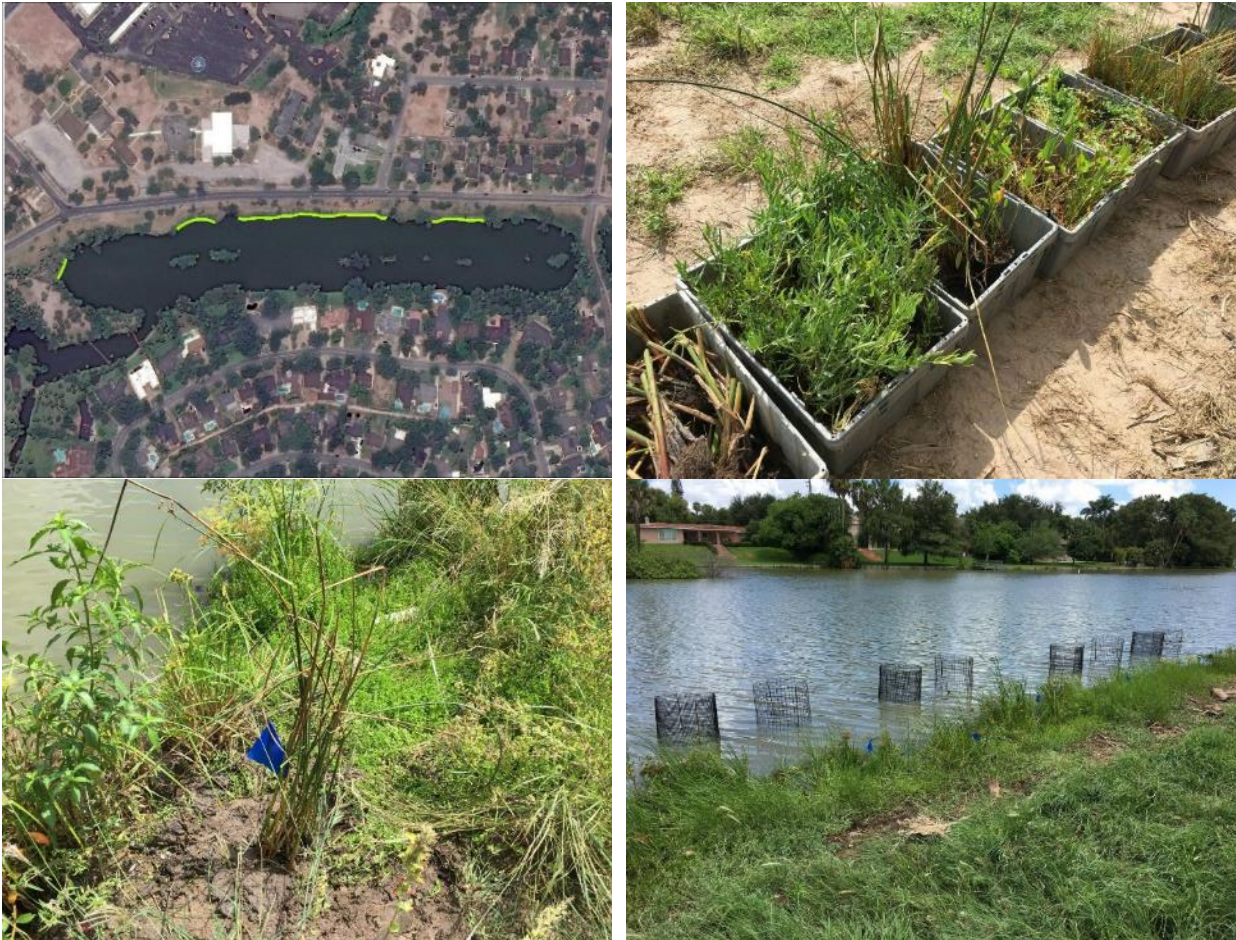
Figure 17. Planting 10 September 2019; top left - highlighted areas show planting locations; top right - containerized aquatic plants; bottom left - planted, flagged emergent vegetation; bottom right - submerged and floating leaf plants were caged for herbivore protection.

Emergent species were planted along the length of the shoreline at the water's edge at 5-ft centers. Submerged and floating-leaved plants were planted in herbivore exclosures or pvc welded-wire ring-cages at three different "founder-colony" locations. These sites would serve a propagule sources to spread aquatic vegetation throughout the resaca wetland. The caged protection was also constructed to determine whether herbivore protection would be needed to prevent plant disturbance of native submerged and floating-leaved aquatic plants throughout the project. At each SAV site, four species were planted (American pondweed, water stargrass, Mexican waterlily, and American white waterlily). Each species was planted in each of three levels of protection: unprotected, protected by 1-in x 1-in mesh, and protected by 2-in x 2-in mesh. All SAV was planted at 1.5-ft depths (Figure 17). One transplant of each species at each site was also planted at 0.5-ft depth unprotected within the wetland vegetated fringe to determine if the natural-vegetation protection served as adequate herbivore masking/protection.

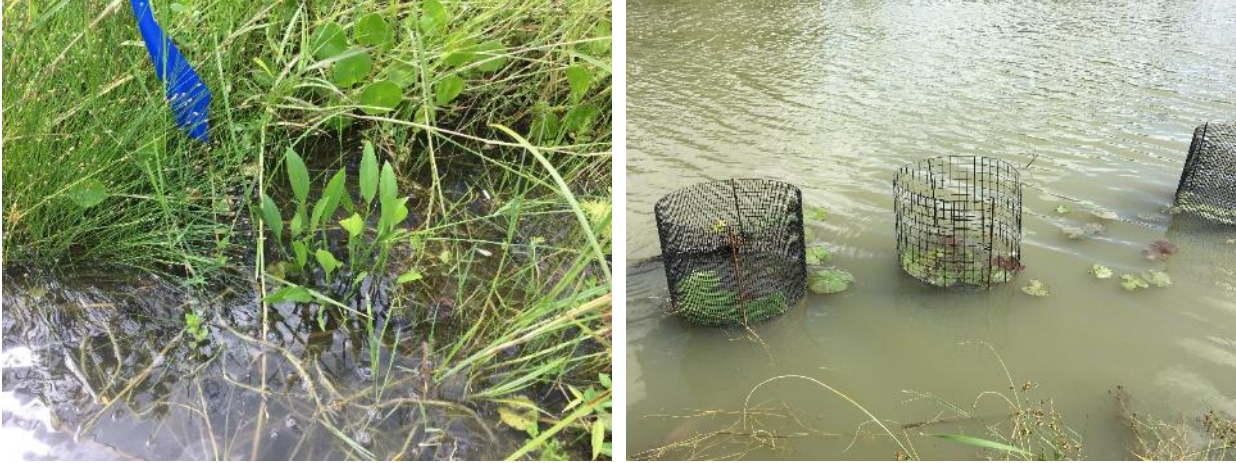
Figure 18. Emergent and aquatic vegetation condition - October 2019, left - delta arrowhead; right - American white waterlily.

Throughout, minimal, if any, herbivory was observed on SAV founder colony sites. This was surprising due to the potential existing herbivores, including nutria, backing turtles, and armored catfish, but fortunate as sites would successfully serve as propagule sources for wetland-wide spread. This was first observed as early as 29 October 2019 (Figure 18). Emergent vegetation was also observed to be successfully established; bulrushes, spikerushes, delta arrowhead, and water hyssop being the most successful species. Appendix D provides aquatic vegetation photographs throughout the project.

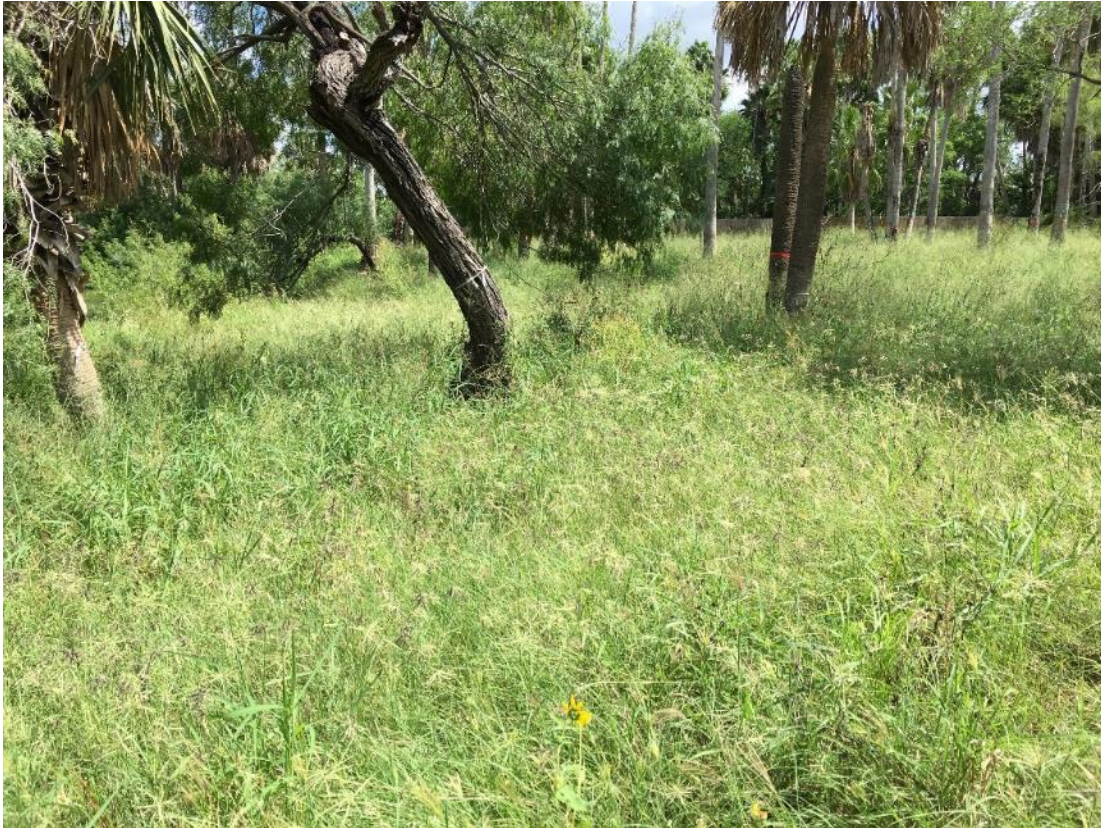
Figure 19. Native seeding condition as of 1 Oct 2019.

In October 2019, seeded areas were again thriving (Figure 19), but scattered woody invasives remained an issue. Thus, a priority on subsequent site visits was the coordination of re-treatments of invasive species seedlings with the contractor. Continued removal of invasive species provides space for establishing native plant communities, which in turn reduces the ability of invasive species to recover. Another assessment occurred on the 13 November 2019 with on-site observations of various invasive species (Brazilian peppertree, Chinese tallow, Chinaberry tree, and river tamarind). They were identified and flagged for contractor removal/re-treatment (Figure 20). Approximately 50 invasive Chinese tallow seedlings marked for removal were sparsely located throughout site, but denser in the north section. Other observations during this time included occurrences of native woody plant recruitment in no-mow areas, including willows and retama. Aquatic plant establishment was successfully progressing with minimal herbivory observed. Unauthorized public disposal of excess brush was found on-site, in which the contractor was made aware of to facilitate its removal.

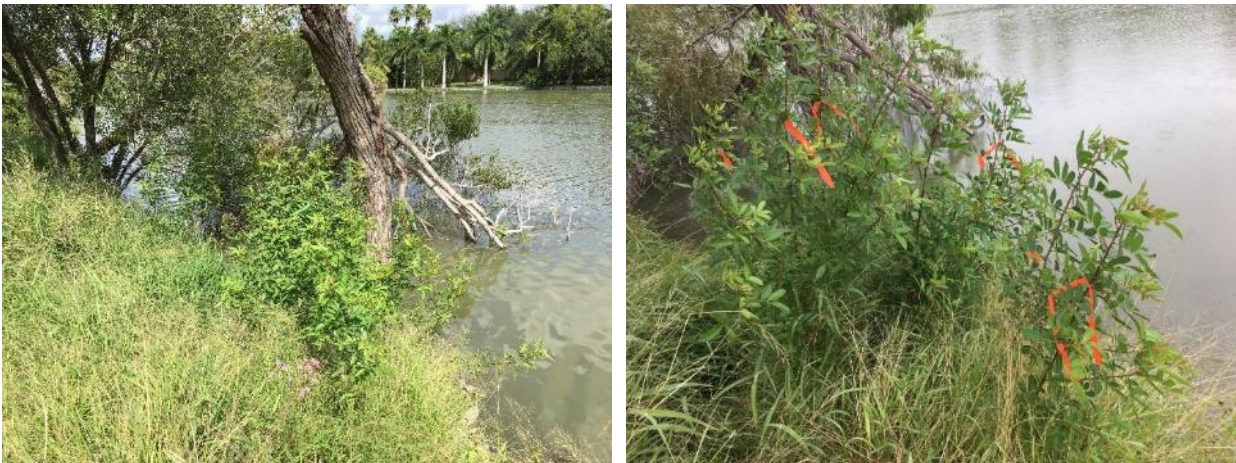
Figure 20. Invasive species re-spouting; marked for removal.

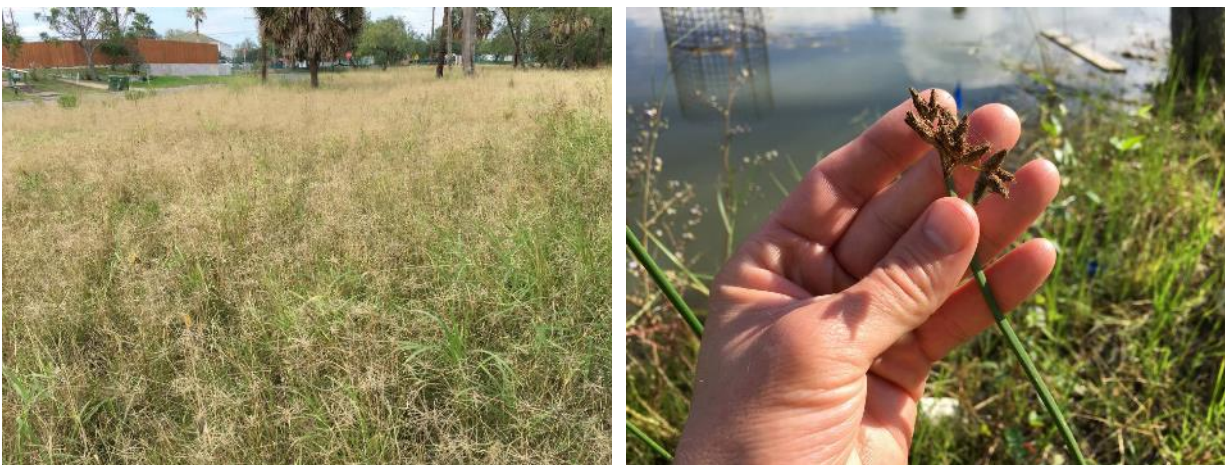
Figure 21. Plant observations during 4 December 2019 site visit; left – seeding development and; right - softstem bulrush showing seeding.

and American whitewater lily planted on 10 September 2019. In the aquatic no-mow riparian zone, a volunteer sedge community was developing and planted softstem bulrush was seeding (Figure 21). It appeared that herbivores were inhibiting potential nuisance cattails but were not yet causing substantial damage to desirable plant species.

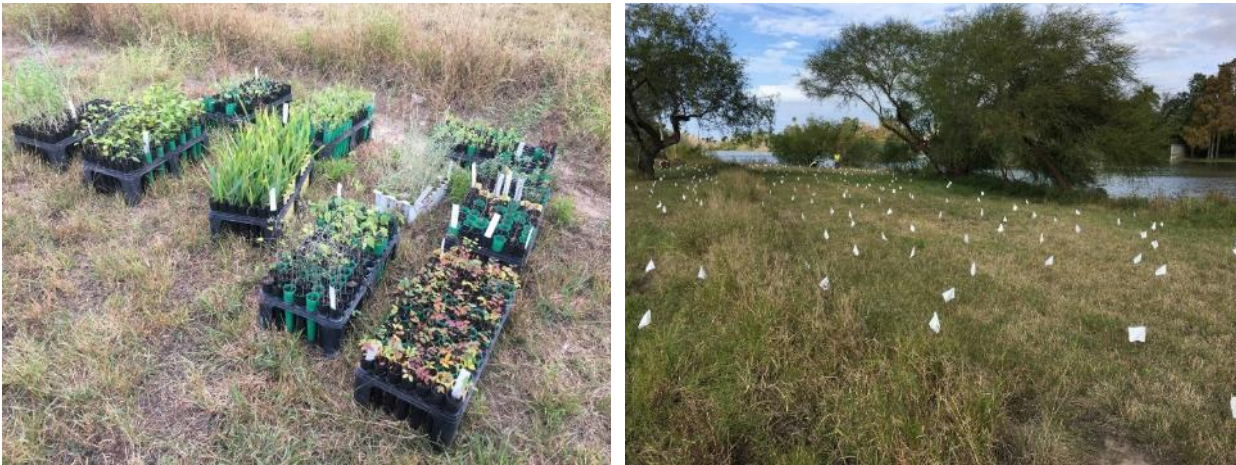
Figure 22. Plantings, 10 January 2020; left – transplants and; right – flagged area

A second woody planting occurred on 10 January 2020 and involved a site-wide planting that included installation of 12 plant species totaling 800 plants (Table 7). Containerized plantings were flagged (Figure 22), while bare areas in the north site that had been reseeded by the contractor were included in the planting area. The contractor completed spot-treatment of Brazilian peppertree and Chinese tallow and removed treated biomass by this time. ERDC-EL-LAERF requested mowing cease following this effort to avoid damage to planted trees and shrubs. In coordination with COB and BPUB, ERDC-EL-LAERF continued monitoring vegetation community development and provided recommendations for any management needs through 2020.

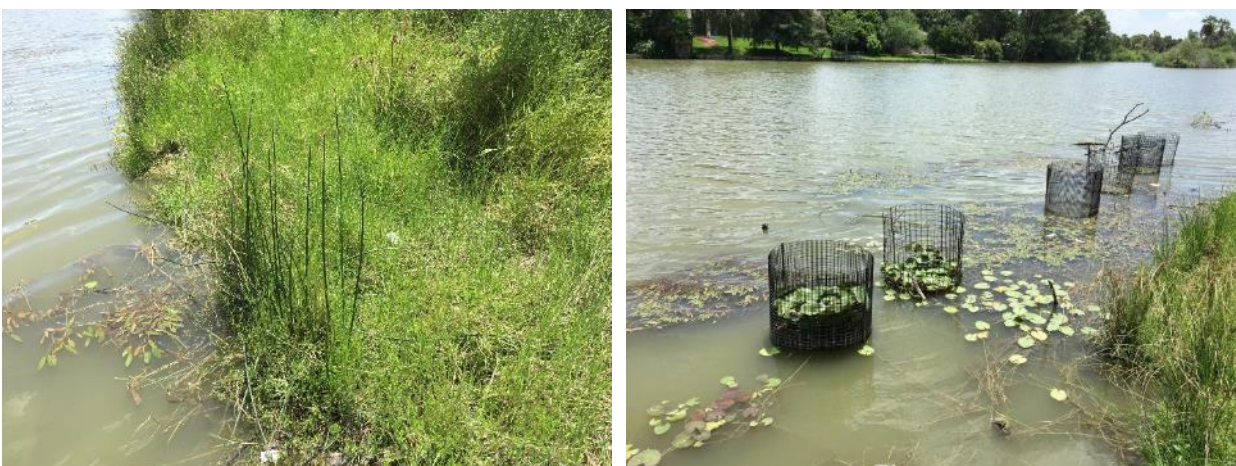
Figure 23. August 2020; aquatic and emergent vegetation spread.

The next assessment occurred in February 2020. Submersed and floating-leaved species protected by exclosures exhibited high survival and showed signs of spread outside of protected areas. Colonies of planted emergent and desirable volunteer species had expanded, dominated by bulrushes and sedges. Containerized plantings (2019) in other areas were also exhibiting good survival and growth, including Texas ebony, Mexican poinciana, and Mexican olive plants. Due to travel restrictions because of the 2020 pandemic, the site was not assessed again until August 2020. As illustrated in Figure 23 and Appendix D, most of the planted vegetation, especially aquatics, were spreading and thriving. However, additional nuisance woody plants were observed to be recruiting at that time, including a few Brazilian peppertree, Chinese tallow, and Chinaberry trees. Woody vegetation survival of the previous two plantings was approximately 65%. Being that the project would be turned over from the Federal to the non-Federal sponsor at the end of the year 2020 and the contractor was off-site already, ERDC-EL-LAERF made arrangements to accomplish adaptive management activities prior to project handoff: (1) treatment of all existing woody vegetation saplings observed and (2) supplemental woody vegetation planting throughout the project site.

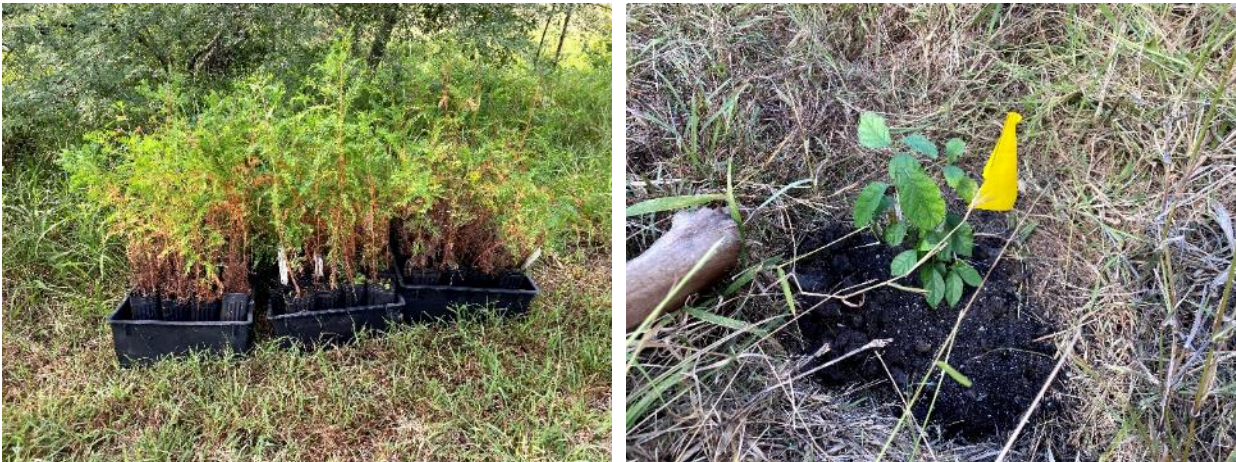
Figure 24. Transplants examples from November 2020 adaptive management supplemental planting; left - Montezuma cypress and; left - anacua.

The final ERDC-EL-LAERF planting occurred in November 2020 and involved a site-wide supplemental / adaptive management planting that included installation of 17 plant species totaling 700 plants. Species planted included anacua, Texas lignum-vitae, catclaw acacia, sabal palm, Mexican holdback, milkweeds, whitebrush, lotebush, Mexican olive, blackbrush acacia, spiny hackberry, Texas ebony, Brazilian bluewood, Texas persimmon, Montezuma cypress, and guajillo (Figure 24). During this time, site conditions were also assessed. SAV founder colony sites were functioning as planned and the most successful woody vegetation remained was anacua, Mexican holdback, Montezuma cypress, Mexican olive, Mexican ash, acacias, sabal palms, hackberries, cedar elms, Texas persimmons, and whitebrush (Appendices D and E).

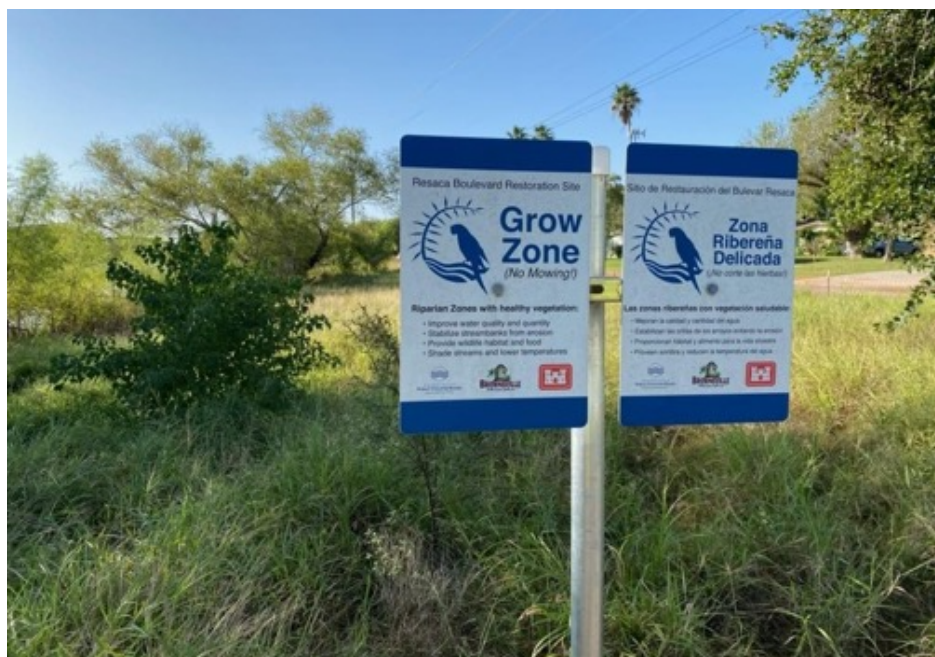
Figure 26. Grow zone signage at RBR.

Mowing or mechanical plant removal is not expected necessary on a regular basis as the entire project area is considered a “grow-zone” (Figure 26). However, targeting growth of tall, aggressive annual species and other unfavorable populations, such as guineagrass can free niche space for native species. This can be coordinated and approved by USACE biologists. Additionally, it is appropriate for the non-Federal sponsor to maintain mowed buffer areas (5-ft) from the road/curb and maintenance path. Herbaceous invasives, such as guineagrass, buffelgrass, KR bluestem, etc. must be culled when coverage is >25% for a 0.25-acre area. An integrated pest management methodology consisting of chemical, mechanical, or hand treatments may be appropriate.
