U.S. ARMY ENGINEER RESEARCH AND DEVELOPMENT CENTER
LEWISVILLE AQUATIC ECOSYSTEM RESEARCH FACILITY

Resaca Boulevard Resaca Section 206 Aquatic Ecosystem Restoration Project:

Native Vegetation Establishment, Monitoring, Adaptive Management, and O&M

January 2021

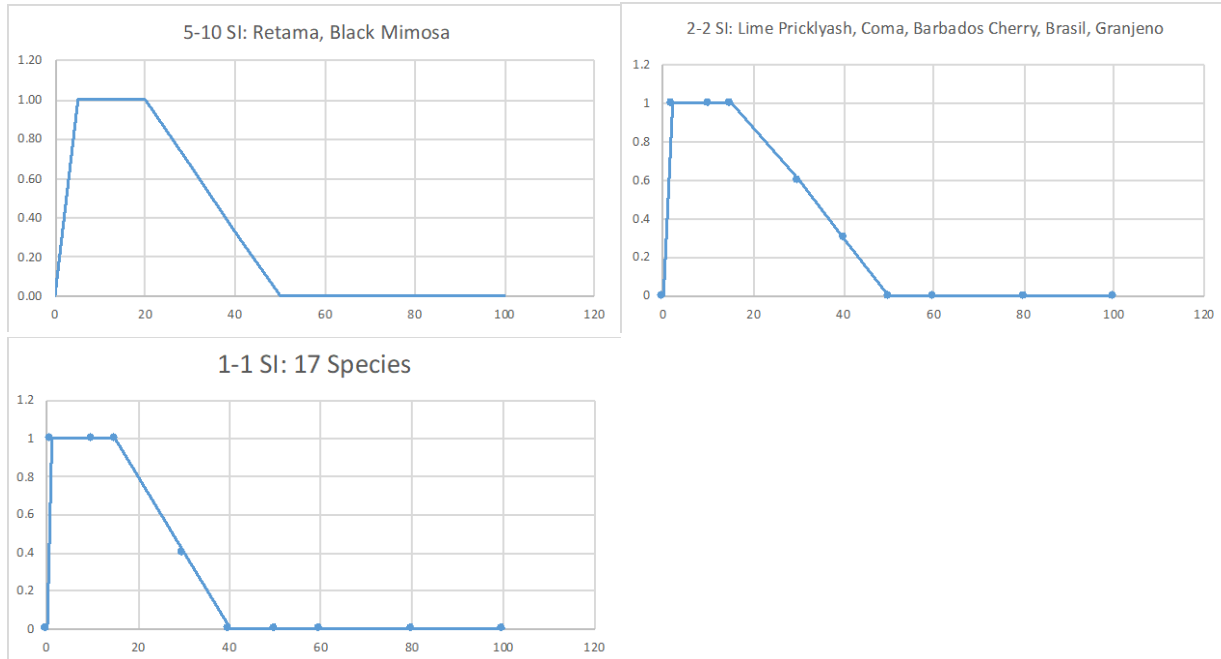
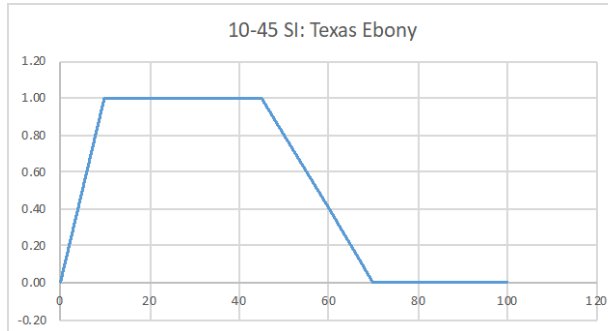
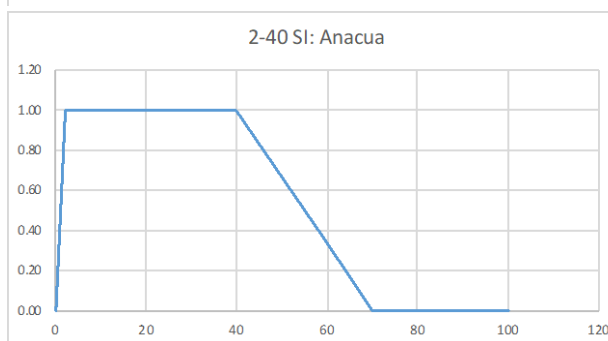
Figure 27. Individual coverage goals at RBR for dominant species; x-axis = percent coverage, y-axis = habitat suitability index or HSI.

Mortality in restoration plots is >50%. Bare area in wetlands is >75% within proximity of founder colonies. Coverage of other locations in project footprint experience bare areas devoid of beneficial vegetation >50%. Use adaptive management techniques and ERDC-EL-LAERF annual vegetation establishment status reports as guide to replace lost plants with species proving suitable and successful at particular locations based upon physical/environmental factors such as open canopy and elevation. Establish woody and herbaceous non-aquatic vegetation during dormant season (December-February); aquatic vegetation can be installed throughout the calendar year. Overall community structure (coverage and diversity) of the native plant community should adhere to the below goals Table 10, and Figure 27.

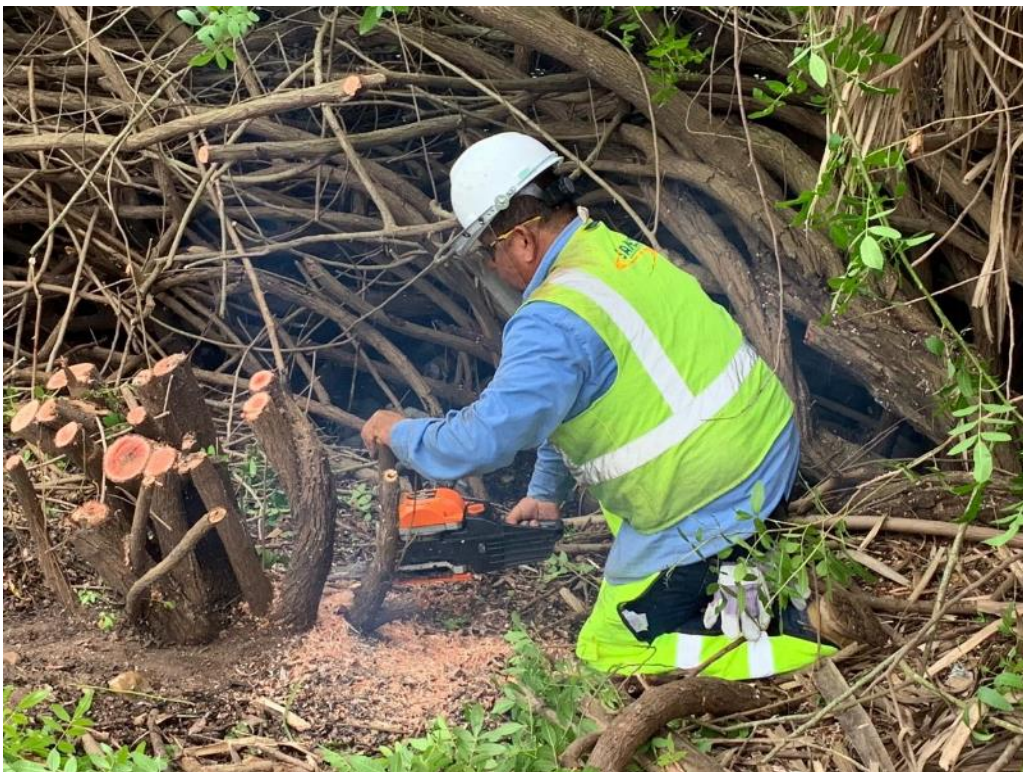
Making the final cuts on the BPT stumps for herbicide (triclopyr) application.

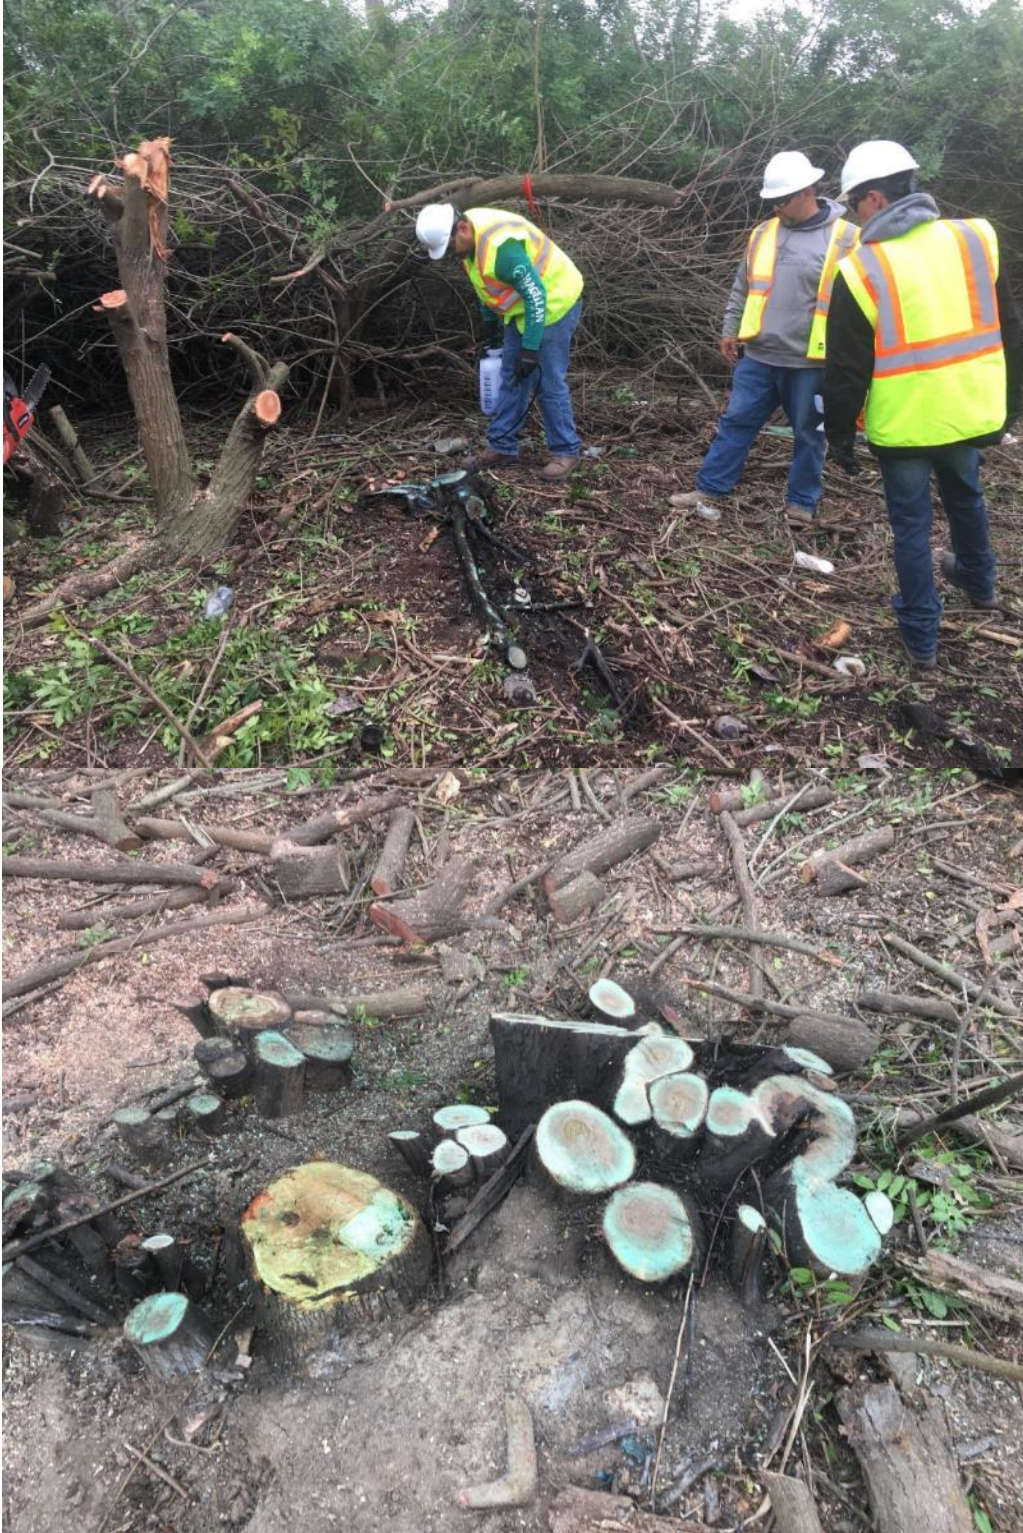
Stump-cut herbicide

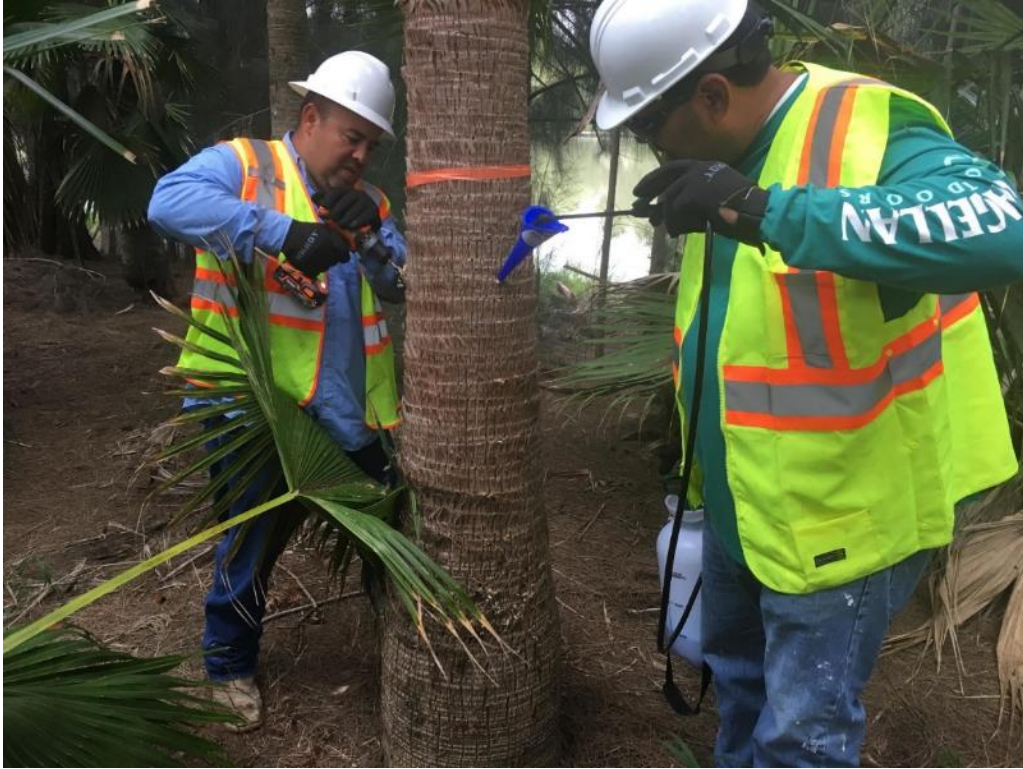
Palm snagging

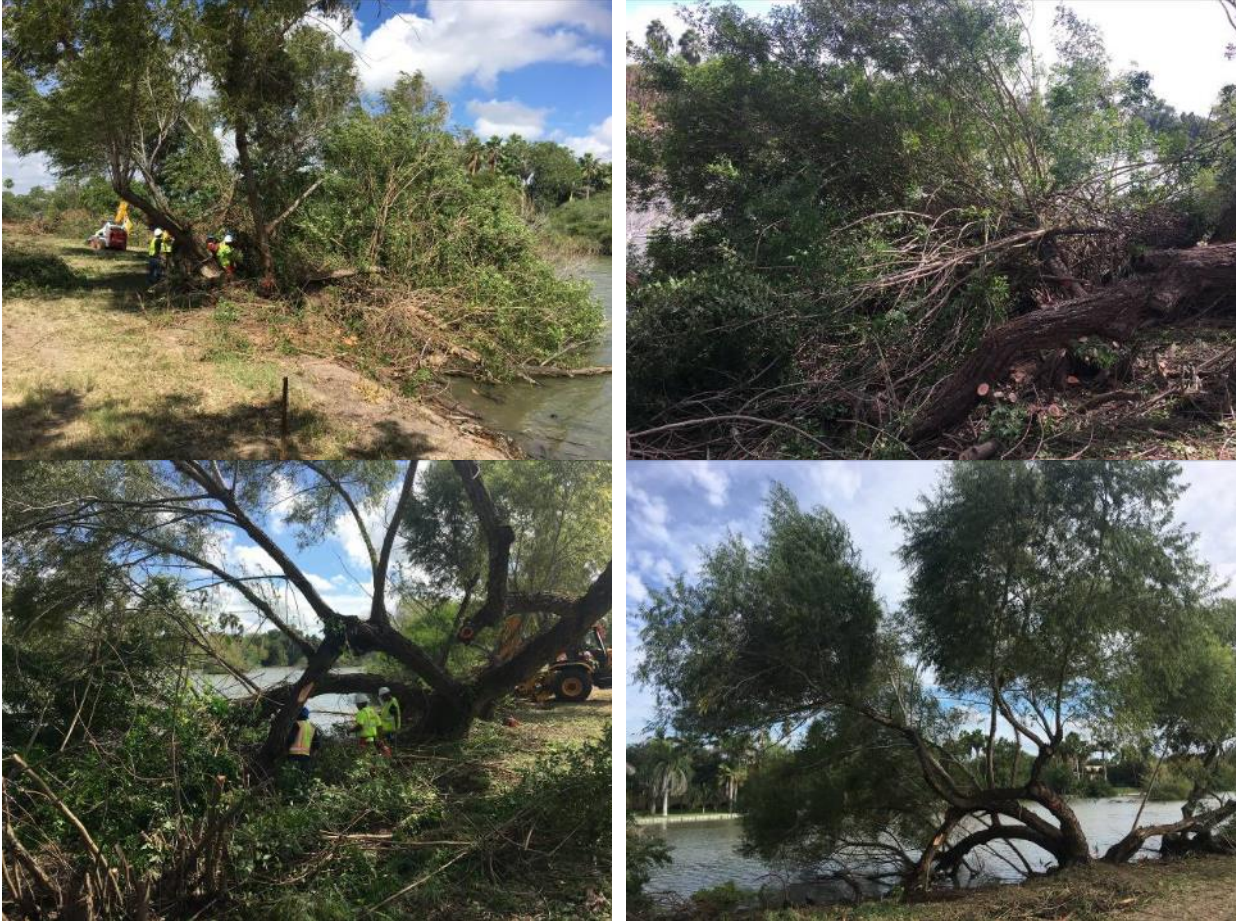
Removing BPT around large native willow
